NB13-0201

Subject: 2007 Edition, Part 3, Supplement 2, S2.13.10.1 – Weld Buildup of Wastage and Grooving in Stayed Areas

Proposal: Update text to clarify additional requirements, fix 2 typo's and removes a reference that is incorrect.

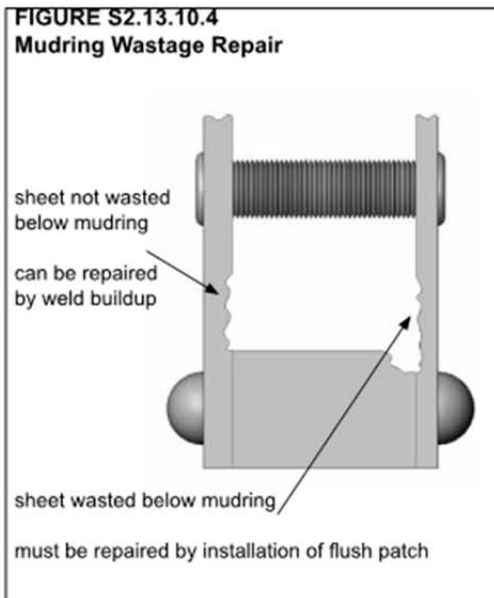
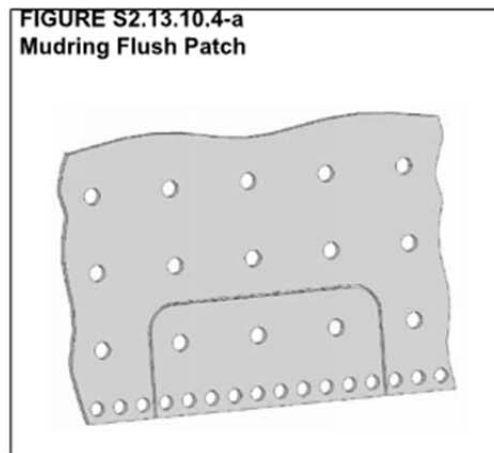
S2.13.10.4 REPAIR OF STAYED FIREBOX SHEETS GROOVED OR WASTED AT THE MUDRING

- b) For mudrings of the locomotive style (See NBIC Part 3, Figure S2.13.10.4), weld buildup shall not be used if the affected section of plate has wasted below 60% of the minimum required thickness per Part 2, Supplement 2 in an area exceeding 3 sq. in. (1,950 sq. mm). (See NBIC Part 3, Figure S2.13.9.1) Repair by weld buildup cannot be used if the wastage extends below the waterside surface of the mudring or if the strength of the structure will be impaired. If extensive welding is required, the affected area shall be removed and replaced with a flush patch.”
- c) Wasted sections that have wasted below 60% of the minimum required thickness and have an area exceeding 3 sq. in. (1,950 sq. mm) shall be repaired by installing a flush patch using full penetration welds.

- a) Mudrings of the Ogee style (knuckle) shall be repaired in accordance with NBIC Part 3, S2.13.11.
- b) For Mudrings of the locomotive style (see NBIC Part 3, Figure S2.13.10.4), grooved or wasted firebox sheets having greater than 60% of the minimum required thickness (see NBIC Part 3, Figure S2.13.9.1) remaining may be repaired by weld buildup provided the wastage does not extend below the waterside surface of the mudring and the strength of the structure will not be impaired. If extensive welding is required, the affected area shall be removed and replaced with a flush patch.

- d) If wastage and grooving extends below the mudring waterside surface and if the plate thickness remaining has been reduced to less than the minimum required thickness, the affected section shall be removed and replaced with a flush patch. (See NBIC Part 3, Figure S2.13.10.4).

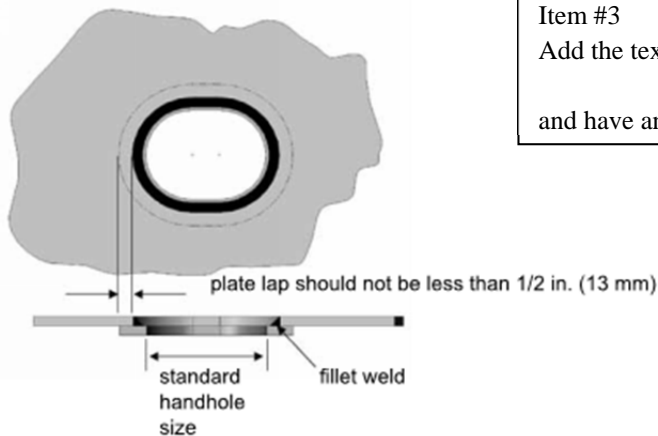
FIGURE S2.13.14.2
Repair of Handhole Opening

- b) Weld buildup is to replace material that has been lost due to wastage and grooving, and is not to replace thickness on the opposite side of the sheet. Weld buildup must be applied to the side of the sheet that is wasted or grooved.
- c) Wasted sections that have wasted below 60% of the minimum required thickness shall be repaired by installing a flush patch using full penetration welds or by the installation of a ring on the inside (pressure side) of the sheet. (See NBIC Part 3, Figure S2.13.14.2).
